**Flood Control Project Maintenance
Levee Inspections**

Fall 2018 Levee Maintenance Deficiency Summary Report

Sacramento River Basin

Reclamation District No. 0010 Honcut

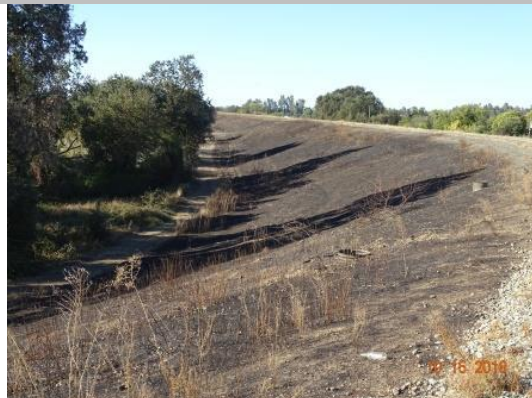
Photo 1 of 1 : FA_2018_RD0010_163_29_20181108_00089.jpg

LM Start	0.02	Rating **	A	Issue No.	29
LM End	7.64	Issue Type +	Ma	Location *	WS
Category	Earthen Levee			GPS Latitude/Longitude	
				Start	End
Item	Vegetation			39.163680 °	39.256061 °
				-121.609574 °	-121.574942 °
DWR ID	DWR_RD0010_01_f_2018_29				
Comment Code					
V1 : Control annual grass and weeds on the levee slopes and easements.					
Inspector Comment					
The annual vegetation is well maintained, Fall 2018.

View looking downstream waterside of the well maintained vegetation, Fall 2018.

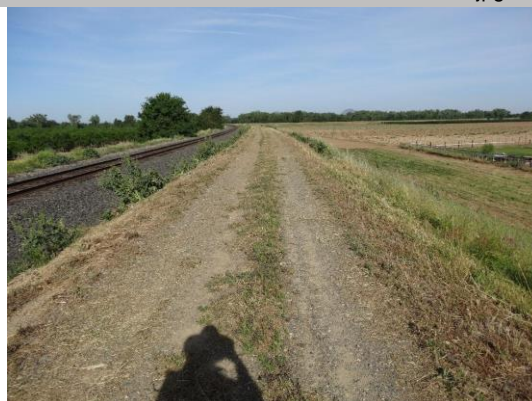
Photo 1 of 3 : UCIP_FA_2018_24806_44540.jpg

Comment Code						
Inspector Comment						
FS_ID:24806 DS_ID:21257 EP_NO: 13015 Repair Type: Non-Urgent Crossing Status: Found UCIP Comments: 04/29/2013 New gravel indicates work was recently completed. Will need to contact owner to obtain information pertaining to work completed. Need to contact owner to determine if crossing is still active and to determine last inspection date. Will need copy of letter showing crossings passed inspection. This crossing is referenced in the USACE Periodic Inspection as item USACE_CESPK_HON1_2013_p_0075. (DWR UCIP - O. Magana) FIELD_STRUCT_DESC: 4-inch steel natural gas pipeline sleeved through an 8-inch pipe through the levee, 30 feet below the crown. Annular space grouted. Cutoff wall on each end within the levee. (Plans to reinforce an existing 4-inch gas main with a parallel 4-inch main through the levee authorized under Permit No. 13015, 1980 - Pacific Gas and Electric Company [PG&E]). [Additional Reference(s): DWR Levee Log, 2005]. FS Date: 4/29/2013

View of levee crown looking upstream.

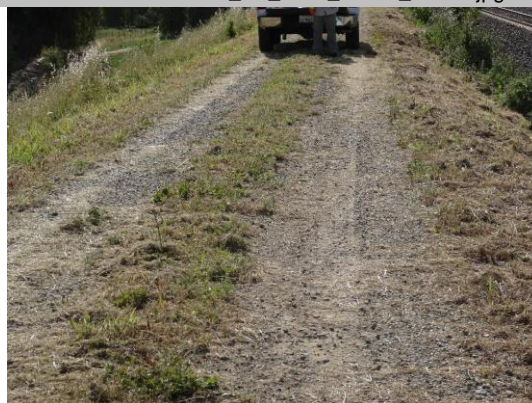
Photo 2 of 3 : UCIP_FA_2018_24806_44541.jpg

View of levee crown looking downstream.

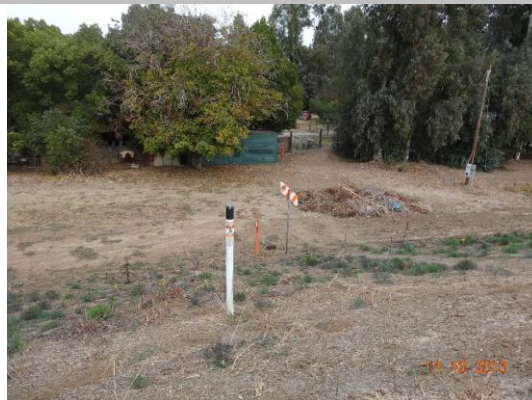
Photo 3 of 3 : UCIP_FA_2018_24806_44543.jpg

Comment Code						
Inspector Comment						
FS_ID:24806 DS_ID:21257 EP_NO: 13015 Repair Type: Non-Urgent Crossing Status: Found UCIP Comments: 04/29/2013 New gravel indicates work was recently completed. Will need to contact owner to obtain information pertaining to work completed. Need to contact owner to determine if crossing is still active and to determine last inspection date. Will need copy of letter showing crossings passed inspection. This crossing is referenced in the USACE Periodic Inspection as item USACE_CESPK_HON1_2013_p_0075. (DWR UCIP - O. Magana) FIELD_STRUCT_DESC: 4-inch steel natural gas pipeline sleeved through an 8-inch pipe through the levee, 30 feet below the crown. Annular space grouted. Cutoff wall on each end within the levee. (Plans to reinforce an existing 4-inch gas main with a parallel 4-inch main through the levee authorized under Permit No. 13015, 1980 - Pacific Gas and Electric Company [PG&E]). [Additional Reference(s): DWR Levee Log, 2005]. FS Date: 4/29/2013

View of landward side--gas marker and conduit line marker.

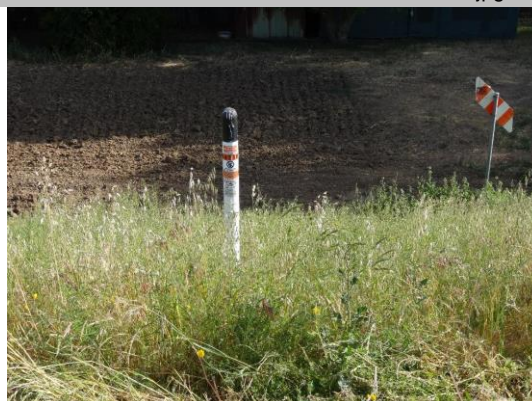
Photo 1 of 2 : UCIP_FA_2018_27713_51366.jpg

LM Start	0.41	Rating **	M	Issue No.	69	
LM End	0.41	Issue Type +	En	Location *		
Category	Supplemental			GPS Latitude/Longitude		
				Start	End	
Item	DWR UCIP Field Study			39.162853 °	39.162853 °	
				-121.602435 °	-121.602435 °	
DWR ID	24654					
Comment Code						
Inspector Comment						
FS_ID:27713 DS_ID:24654 EP_NO: N/A Repair Type: Non-Urgent Crossing Status: Indicator Found UCIP Comments: 04/29/2013 Need to contact owner--unable to determine if crossing is authorized (no permit found) also need to determine if crossing goes through levee. (DWR UCIP - O. Magana) FIELD_STRUCT_DESC: Fiber optics line markers on levee slope. Unable to determine if line goes through the levee. This line was field discovered. FS Date: 4/29/2013

View of landward side--communication line marker.

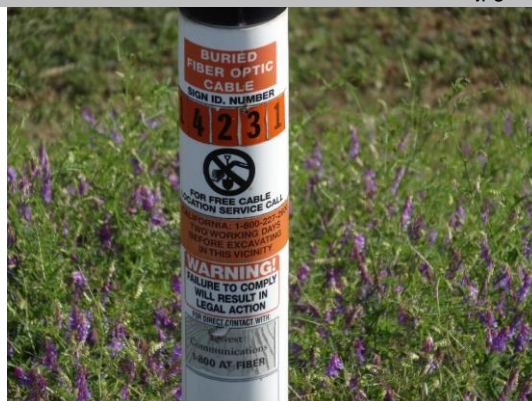
Photo 1 of 2 : UCIP_FA_2018_27710_51361.jpg

FS_ID:27710
DS_ID:24655
EP_NO: N/A
Repair Type: Non-Urgent
Crossing Status: Indicator Found
UCIP Comments: 04/29/2013 Need to contact owner--unable to determine if crossing is authorized (no permit found) also need to determine if crossing goes through levee. (DWR UCIP - O. Magana)
FIELD_STRUCT_DESC: Fiber optics line markers on levee slope.
Unable to determine if line goes through the levee. This line was field discovered.
FS Date: 4/29/2013

Contact information for fiber optic cable and ID number.

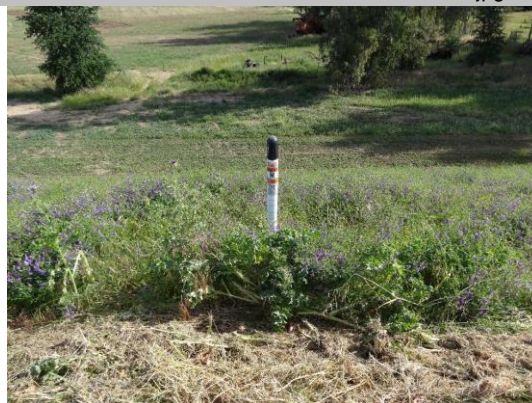
Photo 2 of 2 : UCIP_FA_2018_27710_51360.jpg

View of marker located on landward side.

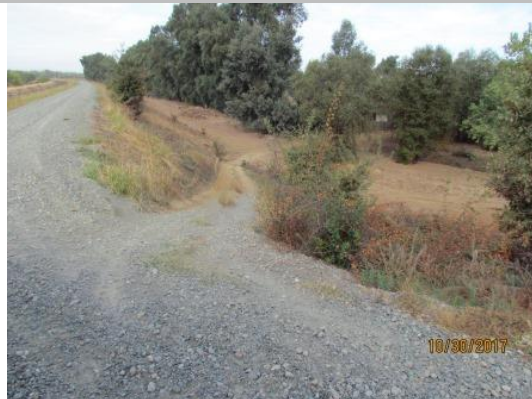
Photo 1 of 1 : FA_2018_RD0010_163_48_20180918_00014.jpg

LM Start	0.72	Rating **	M	Issue No.	48
LM End	0.72	Issue Type +	Ma	Location *	LS
Category	Earthen Levee			GPS Latitude/Longitude	
				Start	End
Item	Slope Stability			39.161198°	39.161198°
				-121.597102°	-121.597102°
DWR ID	DWR_RD0010_01_f_2013_48				
Comment Code					
S3 : Repair the levee slope damaged by vehicle traffic and prevent access where possible.					
Inspector Comment					
Ramp is caused by constant ATV foot traffic use on levee slope. Fall 2018.

View of the slope stability caused by foot traffic on the landward side of the levee looking downstream.

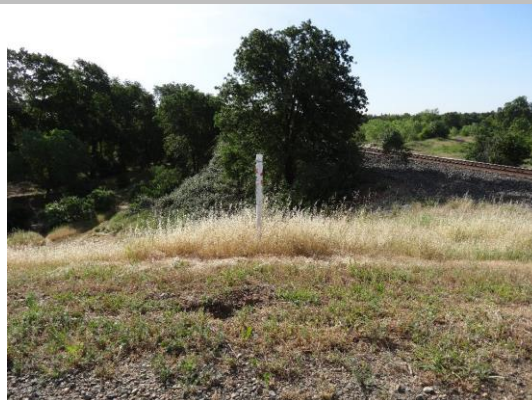
Photo 1 of 2 : UCIP_FA_2018_27715_51371.jpg

LM Start	0.72	Rating **	M	Issue No.	71	
LM End	0.72	Issue Type +	En	Location *		
Category	Supplemental			GPS Latitude/Longitude		
				Start	End	
Item	DWR UCIP Field Study			39.161229°	39.161229°	
				-121.597072°	-121.597072°	
DWR ID	24656					
Comment Code						
Inspector Comment						
FS_ID:27715						
DS_ID:24656						
EP_NO: N/A						
Repair Type: Non-Urgent						
Crossing Status: Indicator Found						
UCIP Comments: 04/29/2013 Need to contact owner--unable to determine if crossing is authorized (no permit found) also need to determine if crossing goes through levee. (DWR UCIP - O. Magana)						
FIELD_STRUCT_DESC: Fiber optics line markers on levee slope.						
Unable to determine if line goes through the levee. This line was field discovered.						
FS Date: 4/29/2013

View of marker located on waterward side.

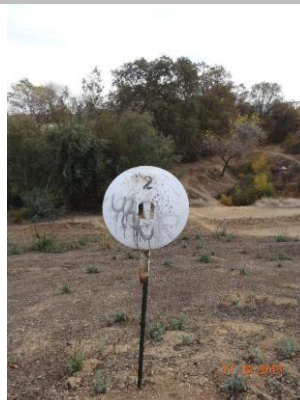
Photo 1 of 3 : UCIP_FA_2018_50058_51415.jpg

FS_ID:50058
DS_ID:21258
EP_NO: N/A
Repair Type: Non-Urgent
Crossing Status: Found
UCIP Comments: 7/01/2016 Gate has been repaired--WS gate is functional. LS gate still needs new stem for the gate to properly function--stem is bent. USACE's PI issue references permit number 13710 this is incorrect permit is associated with DS_ID 21259 (CLM 0.767). (DWR UCIP - omagana)4/29/2013 Damaged flap gate on waterward side and damaged stem on screw gate on landward side. Need to contact owner to determine if crossing is still active. If crossing is still in use owner will need to address damage on flap gate and screw gate. If crossing is no longer in use owner will need to contact the CVFPB to comply with Title 23. This crossing is referenced in the USACE Periodic Inspection as item USACE_CESPK_HON1_2013_p_0053 and 0057. (DWR UCIP - omagana)
FIELD_STRUCT_DESC: 24-inch corrugated metal gravity drainage pipe through the levee, 31 feet below the crown. Two corrugated metal cutoff walls around pipe. Concrete headwall at each end. Flap gate on the waterside (WS) end. Slide gate on the landside (LS) end. Pipe discharges into 6-foot concrete splash apron on the WS. [Additional Reference(s): DWR Levee Log, 2005. USACE Sacramento O&M Manual 151, May 1953, (Station 46+60)].

View of WS--Marker indicates crossing is labelled as 2.

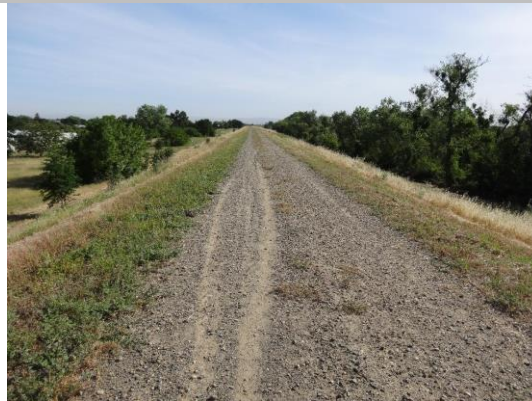
Photo 2 of 3 : UCIP_FA_2018_50058_51410.jpg

View of levee crown looking downstream.

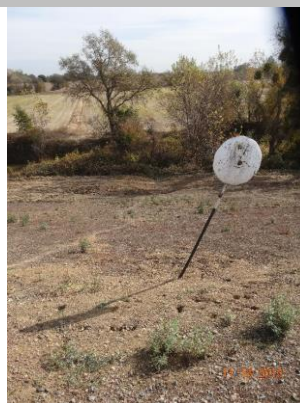
Photo 1 of 3 : UCIP_FA_2018_27748_51453.jpg

Comment Code					
Inspector Comment					
FS_ID:27748					
DS_ID:21261					
EP_NO: N/A					
Repair Type: No Action Needed					
Crossing Status: Found					
UCIP Comments: 04/29/2013 No signs of damage to levee present during inspection. This crossing is referenced in the USACE Periodic Inspection as item USACE_CESPK_HON1_2013_p_0037 and 0040. (DWR UCIP - O. Magana)					
FIELD_STRUCT_DESC: 24-inch corrugated metal gravity drainage pipe through the levee, 29.5 feet below the crown. Two corrugated metal cutoff walls around the pipe on each end. Slide gate on the landside (LS) end. Flap gate on the waterside (WS) end. Concrete headwall at the LS toe. [Additional Reference(s): DWR Levee Log, 2005. USACE Sacramento O&M Manual 151, May 1953, (Station 37+66)].					
FS Date: 4/29/2013

View of waterward side--slope and marker for pipe crossing.

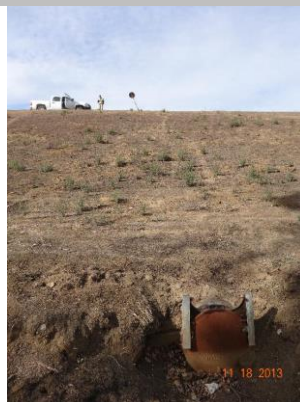
Photo 2 of 3 : UCIP_FA_2018_27748_51450.jpg

View of slope located on waterward side.

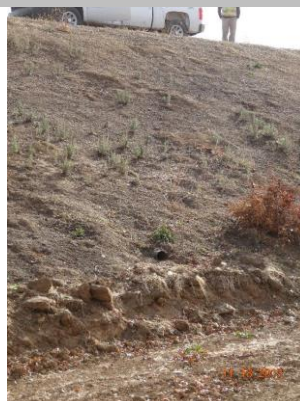
Photo 1 of 1 : UCIP_FA_2018_40545_51418.jpg

Comment Code					
Inspector Comment					
FS_ID:40545 DS_ID:21260 EP_NO: 4555 Repair Type: Non-Urgent Crossing Status: Indicator Found UCIP Comments: 04/29/2013 Pipe is approximately 4-6 inches in diameter located near the toe of levee. Crossing is approximately 50 feet downstream of 24-inch pipe. Need to contact owner to determine status of this crossing and to verify the purpose of crossing. If crossing is no longer in use owner will need to contact the CVFPB to comply with Title 23. (DWR UCIP - O. Magana) FIELD_STRUCT_DESC: *ABANDONED* 6-inch steel drainage discharge pipe through the levee, 1 foot below the crown. Siphon breaker on the waterside (WS) shoulder. Pump at the landside (LS) toe. Revetment around the discharge end of the pipe. Pipe drains into a ditch at the WS toe. Pipe is not buried in berms. Gravel pad over pipe across levee crown for vehicular access. (Plans for installing a drainage pipe across the levee authorized under Permit No. 4555, 1964 - Ledbetter, Carbah, and Huddle). [Additional Reference(s): DWR Levee Log, 2005]. FS Date: 4/29/2013

Pipe through levee near waterward toe.

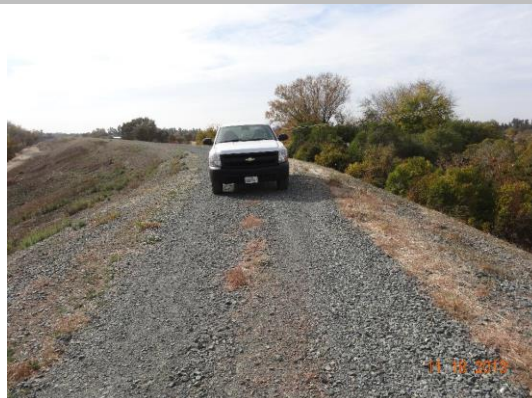
Photo 1 of 3 : UCIP_FA_2018_27725_51386.jpg

Comment Code						
Inspector Comment						
FS_ID:27725 DS_ID:21262 EP_NO: N/A Repair Type: Non-Urgent Crossing Status: Found UCIP Comments: 04/29/2013 Crossing appears not to be in use--need to contact owner. Need to coordinate with owner to determine status of crossing. If crossing is no longer in use owner will need to contact the CVFPB to comply with Title 23. This crossing is referenced in the USACE Periodic Inspection as item USACE_CESPK_HON1_2013_p_0012. (DWR UCIP - O. Magana) FIELD_STRUCT_DESC: 10-inch steel irrigation discharge pipe through the levee, 7.3 feet below the crown. Siphon breaker in a corrugated metal pipe (CMP) riser on the waterside (WS) slope. Pump on the WS berm. Pump not present. Switch house on the WS slope. No switch house present. 24-inch concrete standpipe at the landside (LS) toe. Concrete pad is still present on the WS. [Additional Reference(s): DWR Levee Log, 2005. USACE Sacramento O&M Manual 151, May 1953, (Station 14+82)]. FS Date: 4/29/2013

View of levee crown looking upstream.

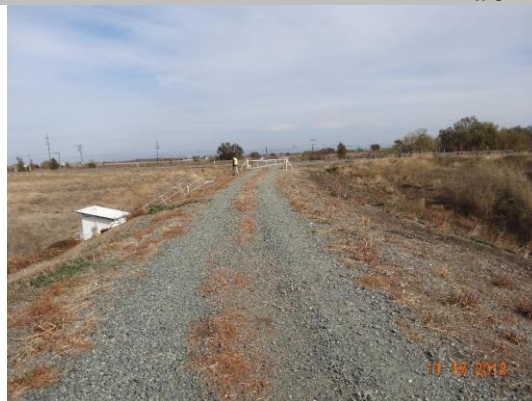
Photo 2 of 3 : UCIP_FA_2018_27725_51387.jpg

View of levee crown looking downstream.

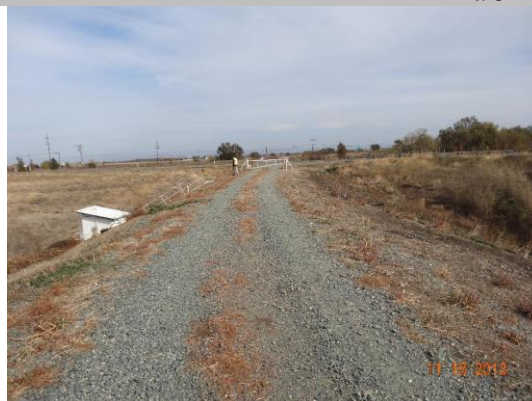
Photo 2 of 3 : UCIP_FA_2018_24810_44577.jpg

Comment Code						
Inspector Comment						
FS_ID:24810 DS_ID:21263 EP_NO: N/A Repair Type: Non-Urgent Crossing Status: Found UCIP Comments: 04/29/2013 Pipe has been capped on waterward side--see photos. Need to coordinate with DWR Inspector to determine whether crossing is compliant with Title 23. This crossing is referenced in the USACE Periodic Inspection as item USACE_CESPK_HON1_2013_p_0016. (DWR UCIP - O. Magana) FIELD_STRUCT_DESC: 10-inch steel irrigation discharge pipe through the levee, 6.8 feet below the crown. Steel cutoff plate around the pipe at the center of the levee. Siphon breaker in corrugated metal pipe (CMP) riser on the waterside (WS) slope. Pump on a concrete base on the WS berm, not present. 36-inch concrete standpipe at the landside (LS) toe. Metal shed and service pole on the WS slope, not present. [Additional Reference(s): DWR Levee Log, 2005. USACE Sacramento O&M Manual 151, May 1953, (Station 14+16)]. FS Date: 4/29/2013

View of levee crown looking downstream.

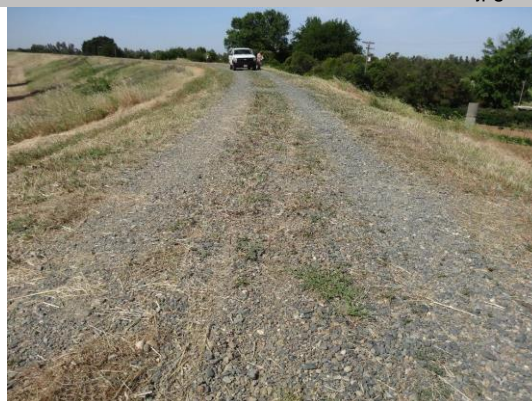
Photo 1 of 3 : UCIP_FA_2018_24811_44582.jpg

Comment Code					
Inspector Comment					
FS_ID:24811 DS_ID:21264 EP_NO: N/A Repair Type: No Action Needed Crossing Status: Found UCIP Comments: 04/29/2013 This crossing is referenced in the USACE Periodic Inspection as item USACE_CESPK_HON1_2013_p_0004. (DWR UCIP - O. Magana) FIELD_STRUCT_DESC: [Reclamation District No. 10 (RD0010) Drainage Plant] 16-inch steel drainage discharge pipe through the levee, 7 feet below the crown. Steel cutoff plate around the pipe at the center of the levee. Siphon breaker on the landside (LS) slope. Flap gate on the waterside (WS) end. Pump in a pit at the LS toe with steps along the LS slope. Saddle and 8-foot splash apron at the discharge end of the pipe. Concrete headwall at the LS toe. Metal shed on the LS slope. [Additional Reference(s): DWR Levee Log, 2005. USACE Sacramento O&M Manual 151, May 1953, (Station 13+88)]. FS Date: 4/29/2013

View of levee crown looking upstream of crossing.

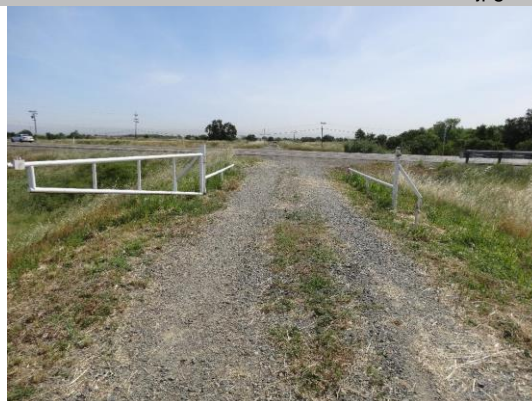
Photo 2 of 3 : UCIP_FA_2018_24811_44581.jpg

View of levee crown looking downstream--access gate near HWY 70.

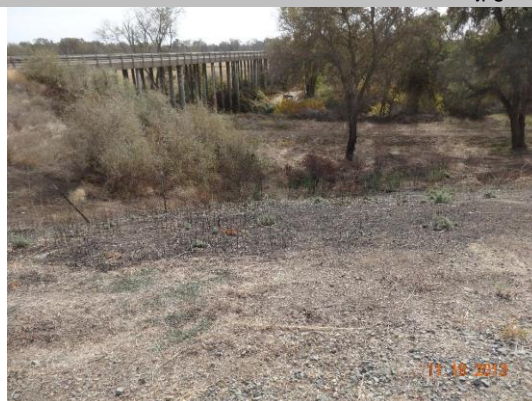
Photo 3 of 3 : UCIP_FA_2018_24811_44585.jpg

Item	DWR UCIP LMA Responsibility			39.168717 °	39.168717 °	
				-121.590570 °	-121.590570 °	
DWR ID	21264					
Comment Code						
Inspector Comment						
FS_ID:24811 DS_ID:21264 EP_NO: N/A Repair Type: No Action Needed Crossing Status: Found UCIP Comments: 04/29/2013 This crossing is referenced in the USACE Periodic Inspection as item USACE_CESPK_HON1_2013_p_0004. (DWR UCIP - O. Magana) FIELD_STRUCT_DESC: [Reclamation District No. 10 (RD0010) Drainage Plant] 16-inch steel drainage discharge pipe through the levee, 7 feet below the crown. Steel cutoff plate around the pipe at the center of the levee. Siphon breaker on the landside (LS) slope. Flap gate on the waterside (WS) end. Pump in a pit at the LS toe with steps along the LS slope. Saddle and 8-foot splash apron at the discharge end of the pipe. Concrete headwall at the LS toe. Metal shed on the LS slope. [Additional Reference(s): DWR Levee Log, 2005. USACE Sacramento O&M Manual 151, May 1953, (Station 13+88)]. FS Date: 4/29/2013

View of waterward side.

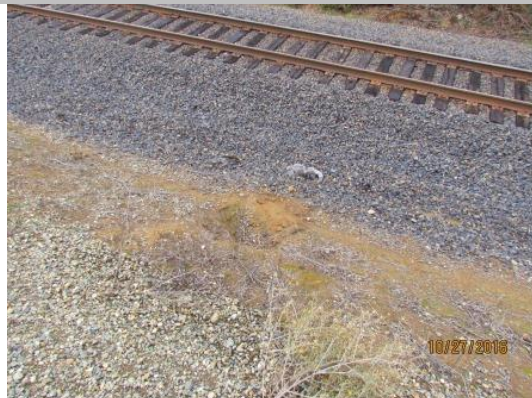
Photo 1 of 1 : FA_2018_RD0010_163_63_20180918_00025.jpg

LM Start	2.09	Rating **	M	Issue No.	63
LM End	2.09	Issue Type +	Ma	Location *	LS
Category	Earthen Levee			GPS Latitude/Longitude	
				Start	End
Item	Animal Control			39.176153 °	39.176153 °
				-121.584958 °	-121.584958 °
DWR ID	DWR_RD0010_01_s_2016_63				
Comment Code					
A3 : No rodents visible, but rodent burrows visible; need to backfill and compact or grout burrows.					
Inspector Comment					
Squirrel hole still are visible but no sign of activity, Fall 2018.

View of squirrel holes on the landside, no rodent activity was observed. Fall 2016.

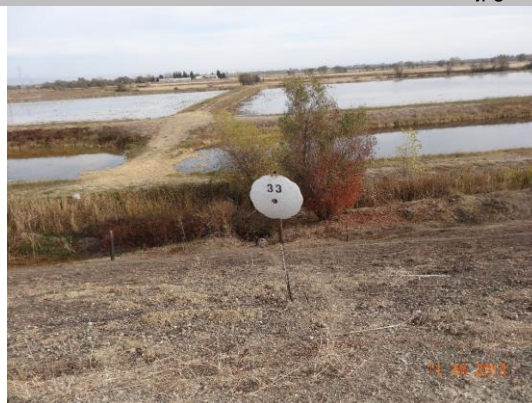
Photo 1 of 3 : UCIP_FA_2018_27745_51429.jpg

Comment Code						
Inspector Comment						
FS_ID:27745						
DS_ID:21271						
EP_NO: N/A						
Repair Type: Non-Urgent						
Crossing Status: Found						
UCIP Comments: 04/29/2013 Unable to determine if crossing is still present on landward side--need to confirm. Need to contact owner to determine status of crossing. This crossing is referenced in the USACE Periodic Inspection as item USACE_CESPK_HON1_2013_p_0185. (DWR UCIP - O. Magana)						
FIELD_STRUCT_DESC: 24-inch gravity drainage pipe of an unknown material through the levee, 30 feet below the crown. Flap gate on the waterside (WS) end. Concrete headwall at each toe. [Additional Reference(s): DWR Levee Log, 2005].						
FS Date: 4/29/2013

View of waterward side--marker indicating crossing visible on waterward shoulder.

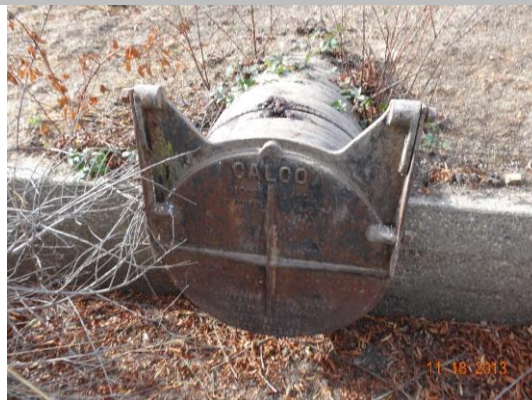
Photo 3 of 3 : UCIP_FA_2018_27745_51431.jpg

Flap gate appears to be in good condition.

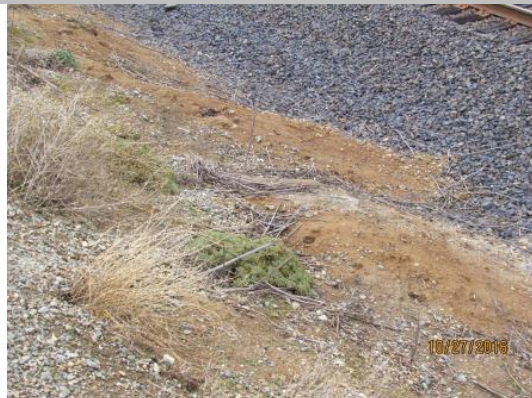
Photo 1 of 1 : FA_2018_RD0010_163_61_20180918_00024.jpg

LM Start	2.16	Rating **	M	Issue No.	61
LM End	2.38	Issue Type +	Ma	Location *	LS
Category	Earthen Levee			GPS Latitude/Longitude	
				Start	End
Item	Animal Control			39.177129°	39.180309°
				-121.584841°	-121.584451°
DWR ID	DWR_RD0010_01_s_2016_61				
Comment Code					
A3 : No rodents visible, but rodent burrows visible; need to backfill and compact or grout burrows.					
Inspector Comment					
Squirrel hole still are visible but no sign of activity, Fall 2018.

View of squirrel holes on the landside slope and toe, no rodent activity was observed. Fall 2016.

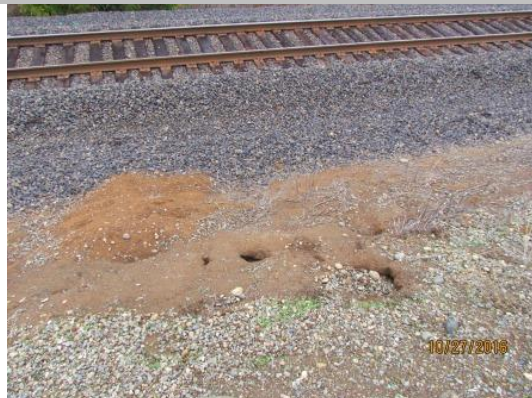
Photo 1 of 1 : FA_2018_RD0010_163_58_20180918_00021.jpg

LM Start	2.67	Rating **	M	Issue No.	58
LM End	2.67	Issue Type +	Ma	Location *	LS
Category	Earthen Levee			GPS Latitude/Longitude	
				Start	End
Item	Animal Control			39.184513 °	39.184513 °
				-121.583924 °	-121.583924 °
DWR ID	DWR_RD0010_01_s_2016_58				
Comment Code					
A3 : No rodents visible, but rodent burrows visible; need to backfill and compact or grout burrows.					
Inspector Comment					
Squirrel hole still are visible but no sign of activity, Fall 2018.

View of squirrel holes on the landside slope and toe, no rodent activity was observed. Fall 2016.

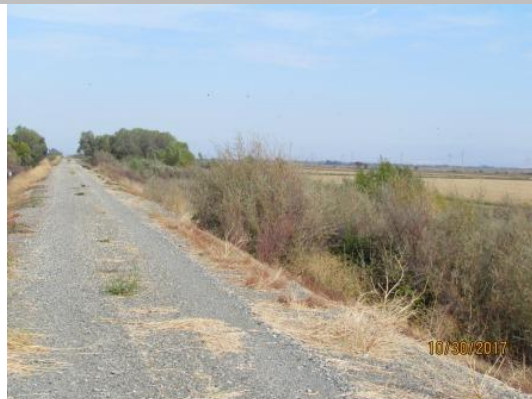
Photo 1 of 1 : FA_2018_RD0010_163_35_20180918_00005.jpg

LM Start	2.70	Rating **	M	Issue No.	35
LM End	2.70	Issue Type +	Ma	Location *	WS
Category	Earthen Levee			GPS Latitude/Longitude	
				Start	End
Item	Trim / Thin Trees			39.184974 °	39.184974 °
				-121.583836 °	-121.583836 °
DWR ID	DWR_RD0010_01_f_2017_35				
Comment Code					
T2 : Thin trees to allow visibility of the ground and room to flood fight.					
Inspector Comment					
Willows on levee slope need to be removed, Fall 2018.

View looking upstream waterside at Willow Trees that need to be removed, Fall 2017.

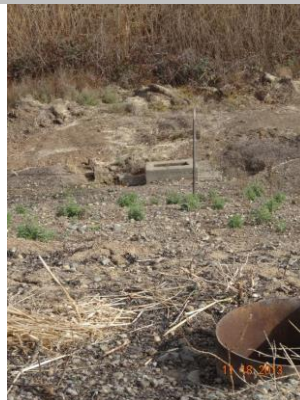
Photo 1 of 3 : UCIP_FA_2018_53137_44608.jpg

View of WS--concrete box located located at WS toe.

FS_ID:53137
DS_ID:21272
EP_NO: 14020
Repair Type: Urgent
Crossing Status: Indicator Found
UCIP Comments: 10/30/2018 Erosion around the concrete box is still present. Erosion does not appear to have progressed since 2013. Unable to determine reason for subsidence around the concrete box located on the WS toe. Recommend internal inspection to determine the condition of the pipe through the levee. Permit recordation indicates that the 10-inch pipe was sleeved through a 16-inch pipe where the annular space between the pipes was grouted, adding some protection to the levee. Photo of the inside of the 10-inch pipe shows that the tar coating is coming off. Continue to monitor site for any changes at the WS toe and the WS slope. Crossing remains Urgent until an internal inspection can be completed to determine the integrity of the pipe through the levee. (O. Magana - DWR UCIP)7/01/2016 Dense vegetation--unable to determine if the sink hole/slope depression noted back in Jan 2013 in the USACE's PI Report is still present. Need to revisit the site once vegetation from the slopes has been cleared. (DWR UCIP - omagana)4/29/2013 Unable to determine status of crossing--sink hole was observed as part of the USACE Periodic Inspection Report dated May 2013. Need to coordinate with owner to determine status of crossing. If crossing is no longer in use owner will need to contact the CVFPB to comply with Title 23. Need to confirm with Finney to determine if pump and controls belong to pipe crossing located on landward side. This crossing is referenced in the USACE Periodic Inspection as item USACE_CESPK_HON1_2013_p_0192. (DWR UCIP - omagana)

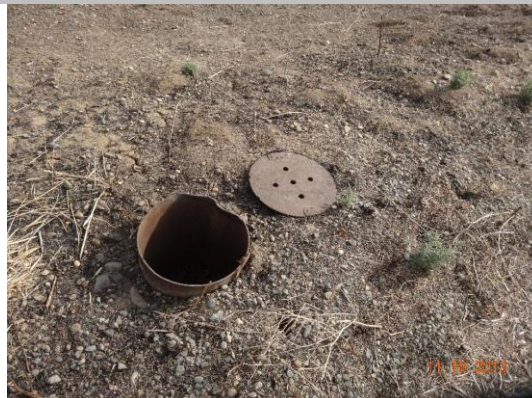
Photo 2 of 3 : UCIP_FA_2018_53137_44605.jpg

View of riser with damage lid located on WS shoulder.

FS_ID:53137
DS_ID:21272
EP_NO: 14020
Repair Type: Urgent
Crossing Status: Indicator Found
UCIP Comments: 10/30/2018 Erosion around the concrete box is still present. Erosion does not appear to have progressed since 2013. Unable to determine reason for subsidence around the concrete box located on the WS toe. Recommend internal inspection to determine the condition of the pipe through the levee. Permit recordation indicates that the 10-inch pipe was sleeved through a 16-inch pipe where the annular space between the pipes was grouted, adding some protection to the levee. Photo of the inside of the 10-inch pipe shows that the tar coating is coming off. Continue to monitor site for any changes at the WS toe and the WS slope. Crossing remains Urgent until an internal inspection can be completed to determine the integrity of the pipe through the levee. (O. Magana - DWR UCIP)7/01/2016 Dense vegetation--unable to determine if the sink hole/slope depression noted back in Jan 2013 in the USACE's PI Report is still present. Need to revisit the site once vegetation from the slopes has been cleared. (DWR UCIP - omagana)4/29/2013 Unable to determine status of crossing--sink hole was observed as part of the USACE Periodic Inspection Report dated May 2013. Need to coordinate with owner to determine status of crossing. If crossing is no longer in use owner will need to contact the CVFPB to comply with Title 23. Need to confirm with Finney to determine if pump and controls belong to pipe crossing located on landward side. This crossing is referenced in the USACE Periodic Inspection as item USACE_CESPK_HON1_2013_p_0192. (DWR UCIP - omagana)

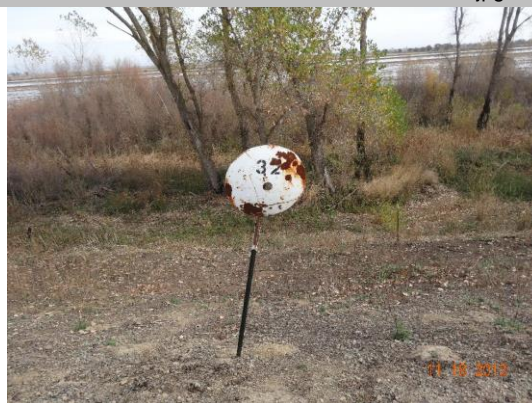
Photo 1 of 3 : UCIP_FA_2018_24816_44611.jpg

Comment Code					
Inspector Comment					
FS_ID:24816 DS_ID:21317 EP_NO: N/A Repair Type: Non-Urgent Crossing Status: Indicator Found UCIP Comments: 04/29/2013 Indicator marker visible on WS; Dense vegetation on waterward toe and landward side access limits the inspector's visibility to identify signs of pipe failure (leaks) along the slope. Recommend removing vegetation along pipe alignment to conduct proper inspection of structure and appurtances. Access to landward side will need to be coordinated with railroad. Need to coordinate with owner to determine status of crossing. If crossing is no longer in use owner will need to contact the CVFPB to comply with Title 23. This crossing is referenced in the USACE Periodic Inspection as item USACE_CESPK_HON1_2013_p_0204. (DWR UCIP - O. Magana) FIELD_STRUCT_DESC: 24-inch corrugated metal gravity drainage pipe through the levee, 23 feet below the crown. Flap gate on the waterside (WS) end. Concrete headwall at each toe. Siphon breaker on the WS shoulder, unable to find. Concrete saddle and apron on the WS. [Additional Reference(s): DWR Levee Log, 2005. USACE Sacramento O&M Manual 151, May 1953, (Station 299+56)]. FS Date: 4/29/2013

View of marker visible on waterward shoulder.

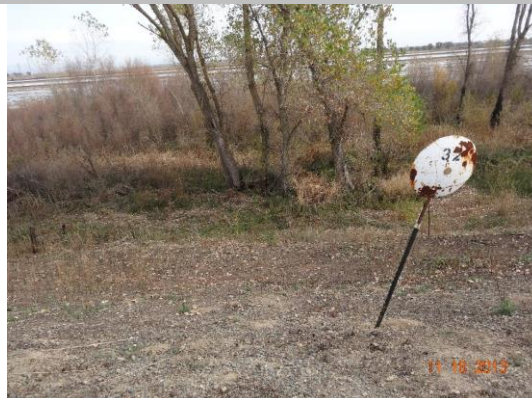
Photo 2 of 3 : UCIP_FA_2018_24816_44610.jpg

View of waterward slope.

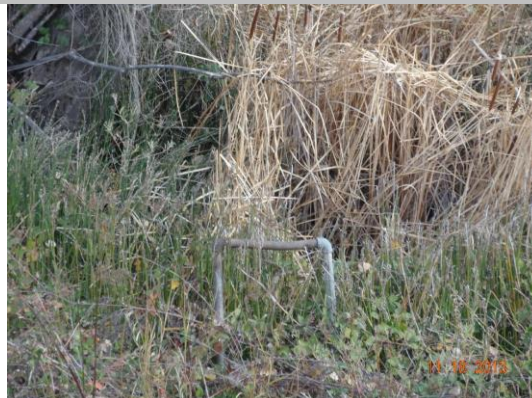
Photo 3 of 3 : UCIP_FA_2018_24816_44612.jpg

Unable to confirm crossing--only visible sign is U shaped pipe through vegetation.

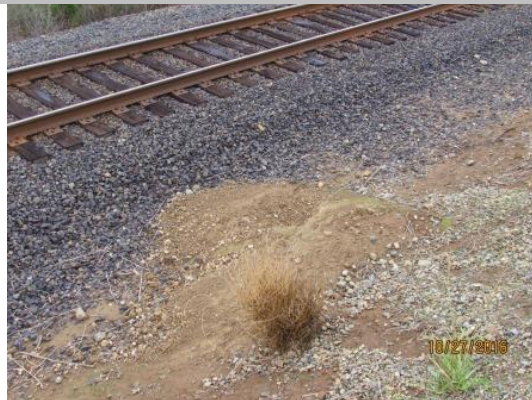
Photo 1 of 1 : FA_2018_RD0010_163_52_20180918_00018.jpg

LM Start	3.69	Rating **	M	Issue No.	52
LM End	3.69	Issue Type +	Ma	Location *	LS
Category	Earthen Levee			GPS Latitude/Longitude	
				Start	End
Item	Animal Control			39.199095 °	39.199095 °
				-121.582118 °	-121.582118 °
DWR ID	DWR_RD0010_01_s_2016_52				
Comment Code					
A3 : No rodents visible, but rodent burrows visible; need to backfill and compact or grout burrows.					
Inspector Comment					
Squirrel holes still are visible but no sign of activity, Fall 2018.

View of squirrel holes on the landside slope and toe, no rodent activity was observed. Fall 2016.

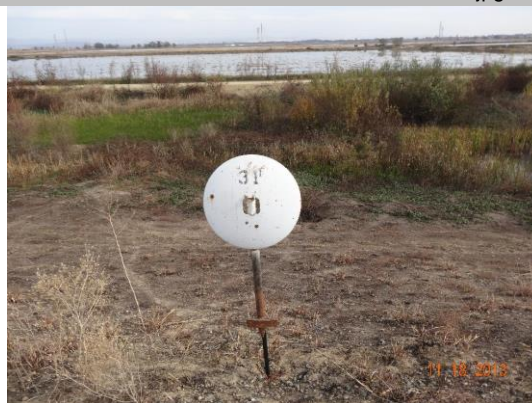
Photo 1 of 3 : UCIP_FA_2018_27746_51436.jpg

View of waterward side--marker for pipe visible on waterward shoulder.

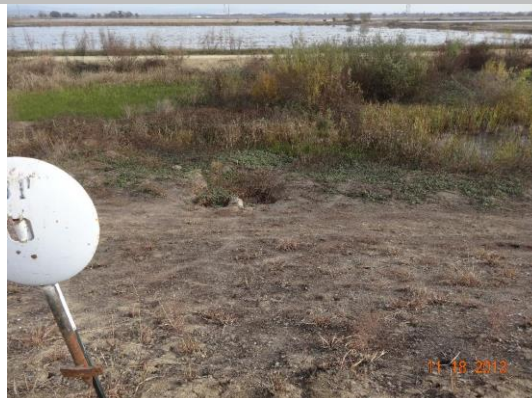
Photo 2 of 3 : UCIP_FA_2018_27746_51435.jpg

View of pipe on waterward toe.

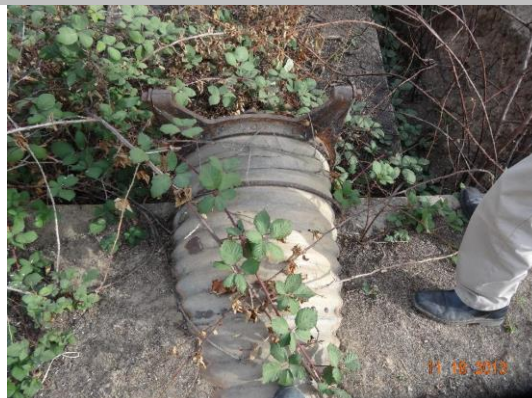
Photo 3 of 3 : UCIP_FA_2018_27746_51439.jpg

View of pipe, headwall, and concrete apron on waterward toe.

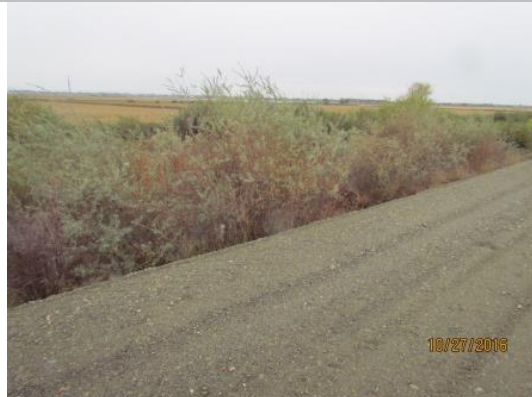
Photo 1 of 1 : FA_2018_RD0010_163_49_20180918_00015.jpg

LM Start	3.93	Rating **	M	Issue No.	49
LM End	3.93	Issue Type +	Ma	Location *	WS
Category	Earthen Levee			GPS Latitude/Longitude	
				Start	End
Item	Trim / Thin Trees			39.202570 °	39.202570 °
				-121.581681 °	-121.581681 °
DWR ID	DWR_RD0010_01_s_2016_49				
Comment Code					
T2 : Thin trees to allow visibility of the ground and room to flood fight.					
Inspector Comment					
Remove small willow trees from levee slope. Fall 2018.

View of small starter willow trees on the landside looking upstream. Fall 2016.

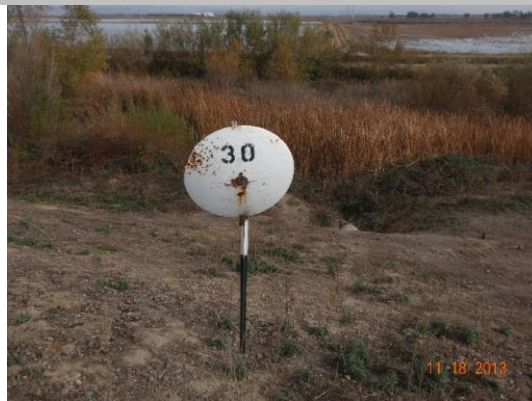
Photo 1 of 3 : UCIP_FA_2018_27747_51441.jpg

Comment Code						
Inspector Comment						
FS_ID:27747						
DS_ID:21274						
EP_NO: N/A						
Repair Type: Non-Urgent						
Crossing Status: Indicator Found						
UCIP Comments: 04/29/2013 sign marker on WS 30; Unable to confirm landward side. This crossing is referenced in the USACE Periodic Inspection as item USACE_CESPK_HON1_2013_p_0232. (DWR UCIP - O. Magana)						
FIELD_STRUCT_DESC: 24-inch corrugated metal gravity drainage pipe through the levee, 18 feet below the crown. Corrugated metal cutoff wall around the pipe at the center of the levee. Flap gate and 6-foot by 6-foot splash apron on the waterside (WS) end. [Additional Reference(s): DWR Levee Log, 2005. USACE Sacramento O&M Manual 151, May 1953, (Station 339+55.10)].						
FS Date: 4/29/2013

View of waterwar side--marker indicating crossing located on waterward shoulder.

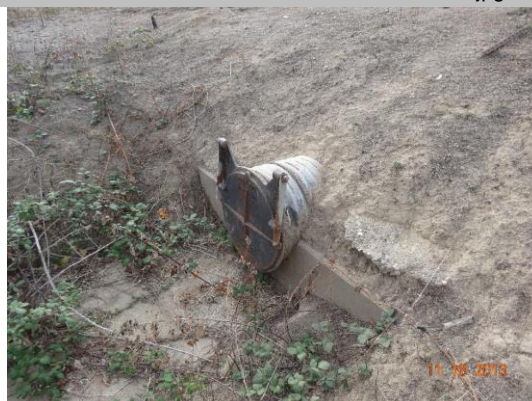
Photo 2 of 3 : UCIP_FA_2018_27747_51445.jpg

View of pipe, flap gate, and headwall located on waterward toe.

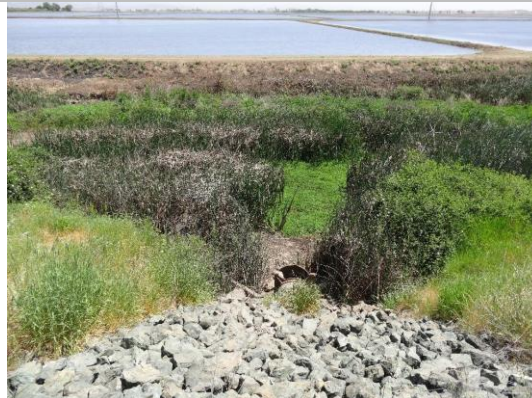
Photo 2 of 3 : UCIP_FA_2018_53138_44809.jpg

UCIP Comments: 10/18/2018 According to the LMA representative, a small pipe repair was completed near the WS gate (pipe was leaking at pipe collar). Pipe has been upgraded from Non-Urgent to Urgent due to the wall deterioration near the outlet and an unknown condition through the levee. Levee is about 20 feet high. Recommend video inspection to determine pipe condition through the levee. This pipe is part of DWR's Deferred Maintenance Project (DMP), video inspection is expected to be completed next year for this crossing. (O. Magana - DWR UCIP)7/01/2016 WS slope appears to be stable; UCIP issue has been downgraded from Urgent to Non-Urgent due to what appears to be a stable slope--no other issues were observed during the site visit. The reason for the Non-Urgent classification is due to the limited documentation available to support extent of repair--need to obtain repair records to determine extent of repair and to determine if pipe was replaced through the levee. (DWR UCIP - omagana)4/29/2013 limited access; steep slopes, and dense vegetation; New riprap has been placed along pipe alignment need to contact owner to determine work authorization. Also need to find out if the design for riprap was due to slope failure at this location. This crossing is referenced in the USACE Periodic Inspection as item USACE_CESPK_HON1_2013_p_0246. (DWR UCIP - omagana)

View of WS during April.

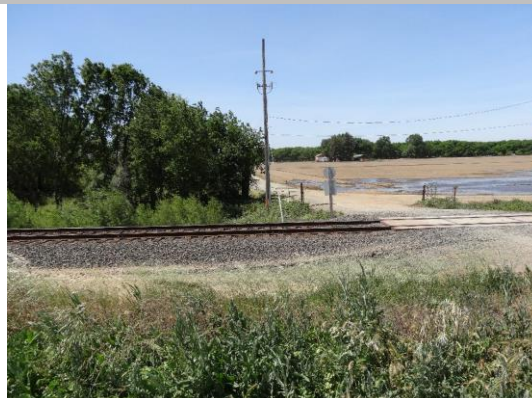
Photo 1 of 3 : UCIP_FA_2018_27531_51124.jpg

Comment Code						
Inspector Comment						
FS_ID:27531 DS_ID:21277 EP_NO: 6127 Repair Type: Non-Urgent Crossing Status: Indicator Found UCIP Comments: 04/29/2013 Recommend removing vegetation along pipe alignment to conduct proper inspection of structure and appurtances. (DWR UCIP - O. Magana) FIELD_STRUCT_DESC: Two 1-inch aluminum electrical conduits through the levee, 3 feet below the crown. Cutoff wall around the conduits at the center of the levee. (Plans to construct a low levee along the bank of the canal authorized under Permit No. 6217, 1968 - Morgan C. Chambers and Edgar Meyer). [Additional Reference(s): DWR Levee Log, 2005]. FS Date: 4/29/2013

LS view overview.

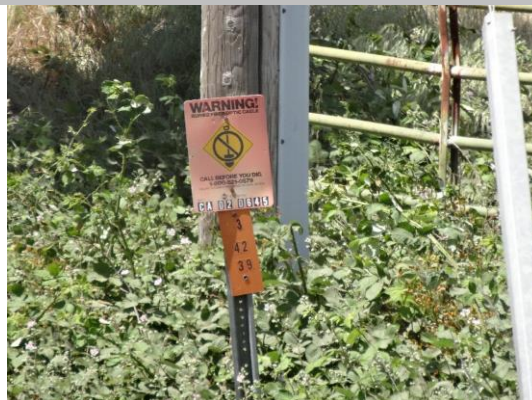
Photo 2 of 3 : UCIP_FA_2018_27531_51123.jpg

Buried fiber optic cable marker located on LS.

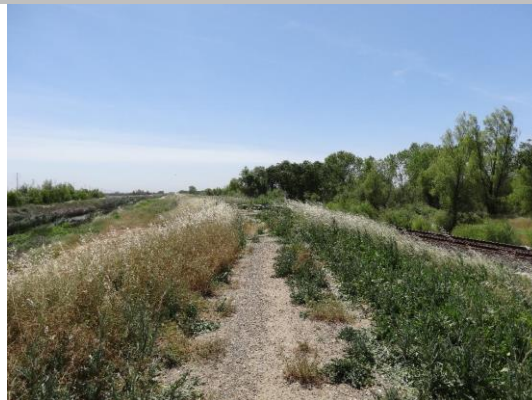
Photo 3 of 3 : UCIP_FA_2018_27531_51122.jpg

View of levee crown.

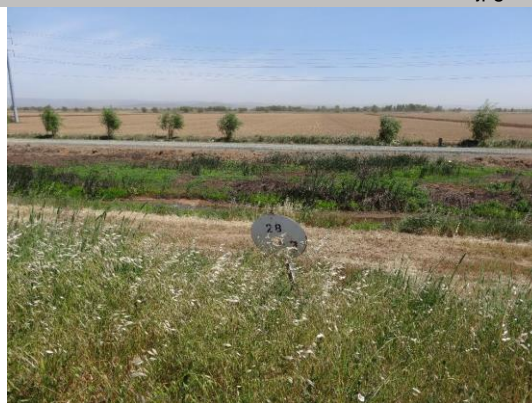
Photo 1 of 3 : UCIP_FA_2018_24438_43503.jpg

Comment Code					
Inspector Comment					
FS_ID:24438 DS_ID:21278 EP_NO: N/A Repair Type: Non-Urgent Crossing Status: Found UCIP Comments: 04/29/2013 Dense vegetation limits the inspector's visibility to identify signs of pipe failure (leaks) along the slope. Recommend removing vegetation along pipe alignment to conduct proper inspection of structure and appurtances. This crossing is referenced in the USACE Periodic Inspection as item USACE_CESPK_HON1_2013_p_0290. (DWR UCIP - O. Magana) FIELD_STRUCT_DESC: 30-inch corrugated metal gravity drainage pipe through the levee, 12.5 feet below the crown. Corrugated metal cutoff wall around the pipe at each shoulder. Flap gate on the waterside (WS) end. Concrete headwall, saddle, and apron on the WS end. [Additional Reference(s): DWR Levee Log, 2005. USACE Sacramento O&M Manual 151, May 1953, (Station 455+00)]. FS Date: 4/29/2013

Marker visible on waterward shoulder.

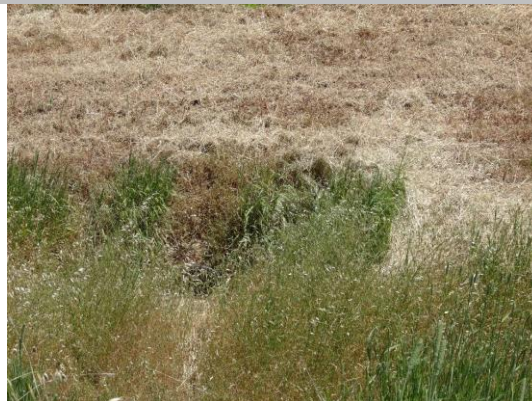
Photo 2 of 3 : UCIP_FA_2018_24438_43502.jpg

View of waterward toe where pipe daylights.

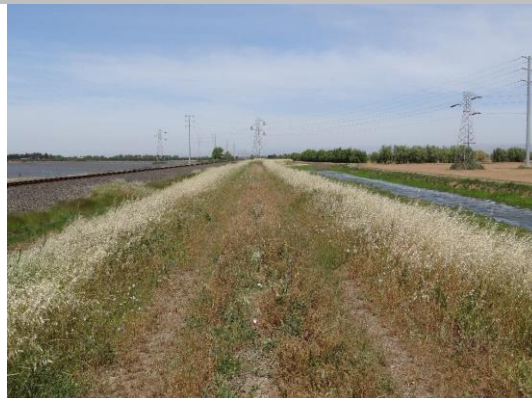
Photo 1 of 3 : UCIP_FA_2018_27532_51129.jpg

Comment Code						
Inspector Comment						
FS_ID:27532 DS_ID:21279 EP_NO: N/A Repair Type: Non-Urgent Crossing Status: Found UCIP Comments: 04/29/2013 Need to clear sediment near gate. Need to coordinate with owner to determine status of crossing. If crossing is no longer in use owner will need to contact the CVFPB to comply with Title 23. This crossing is referenced in the USACE Periodic Inspection as item USACE_CESPK_HON1_2013_p_0291-294. (DWR UCIP - O. Magana) FIELD_STRUCT_DESC: 16-inch steel drainage pipe through the levee, 10.3 feet below the crown. Cutoff wall around the pipe at the center of the levee. Slide gate on the waterside (WS) end. Pipe exposed across irrigation canal on the landside (LS). [Additional Reference(s): DWR Levee Log, 2005. USACE Sacramento O&M Manual 151, May 1953, (Station 473+58)]. FS Date: 4/29/2013

View of levee looking upstream.

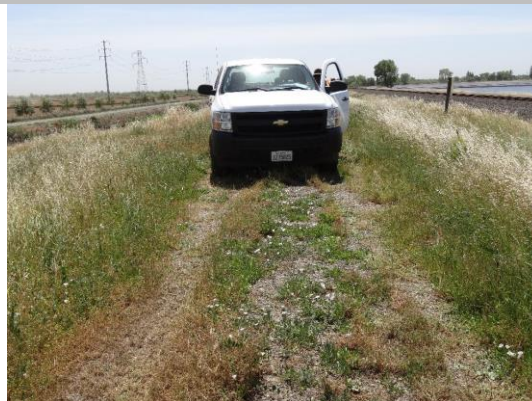
Photo 2 of 3 : UCIP_FA_2018_27532_51128.jpg

View of levee looking downstream.

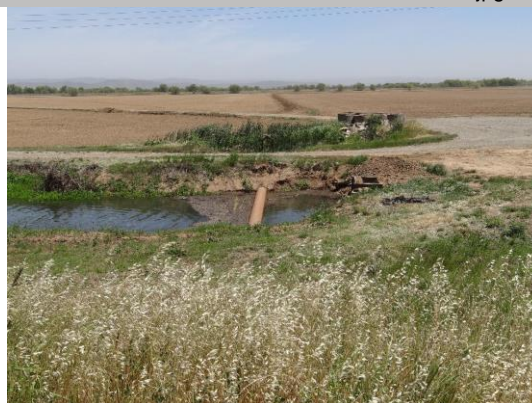
Photo 3 of 3 : UCIP_FA_2018_27532_51130.jpg

View of waterward side--pipe goes through Simmerly Slough.

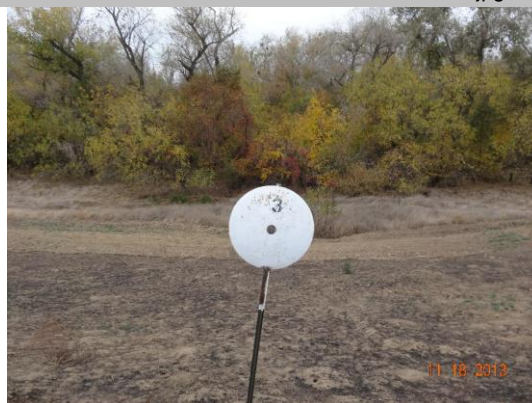
Photo 1 of 3 : UCIP_FA_2018_27533_51135.jpg

Comment Code						
Inspector Comment						
FS_ID:27533						
DS_ID:21280						
EP_NO: N/A						
Repair Type: Non-Urgent						
Crossing Status: Found						
UCIP Comments: 04/30/2013 Recommend removing vegetation and debris along pipe alignment (debris blocking gate on waterward side and vegetation blocking access to screw gate on landward side). Need to coordinate with owner to determine status of crossing. If crossing is no longer in use owner will need to contact the CVFPB to comply with Title 23. This crossing is referenced in the USACE Periodic Inspection as item USACE_CESPK_HON2_2013_p_0027. (DWR UCIP - O. Magana)						
FIELD_STRUCT_DESC: 24-inch corrugated metal gravity drainage pipe through the levee, 25.6 feet below the crown. Corrugated metal cutoff wall around the pipe at each shoulder. Flap gate on the waterside (WS) end. Concrete headwall, saddle, and apron on the WS end. [Additional Reference(s): DWR Levee Log, 2005. USACE Sacramento O&M Manual 151, May 1953, (Station 106+00)].

View of waterward side.

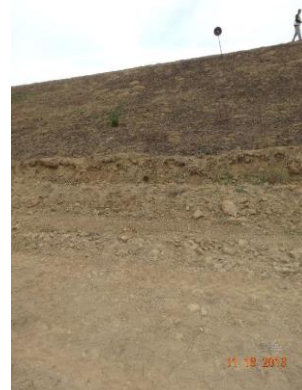
Photo 2 of 3 : UCIP_FA_2018_27533_51137.jpg

View of waterward slope.

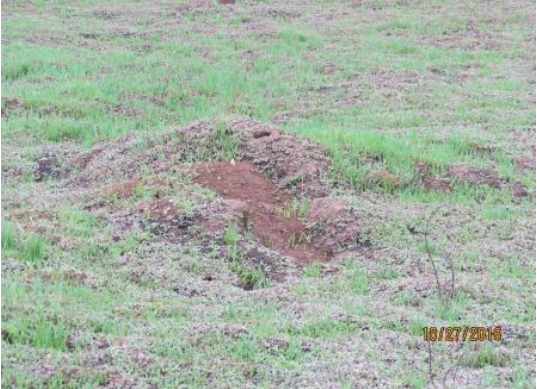
Photo 1 of 1 : FA_2018_RD0010_164_29_20180918_00004.jpg

View of rodent hole that has more than 2 cubic feet of material on the

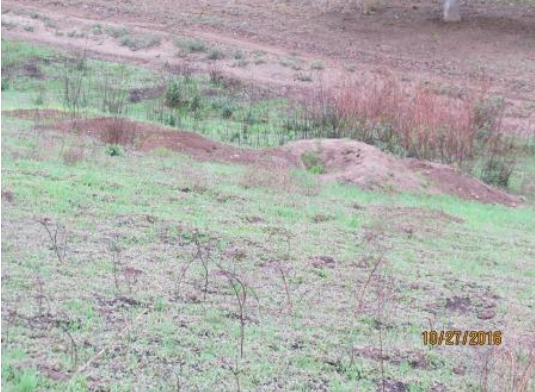
Photo 1 of 1 : FA_2018_RD0010_164_30_20180918_00005.jpg

View of rodent hole that has more than 2 cubic feet of material on the west side.

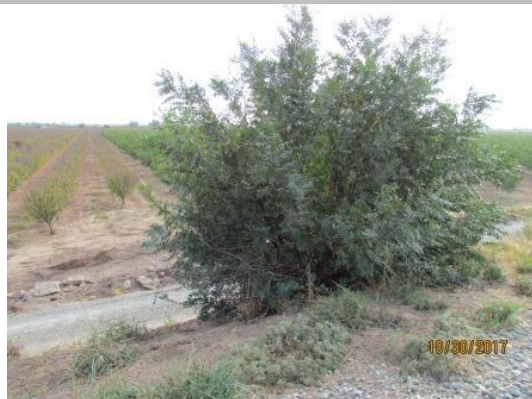
Photo 1 of 1 : FA_2018_RD0010_164_56_20180918_00023.jpg

LM Start	1.16	Rating **	M	Issue No.	56
LM End	1.16	Issue Type +	Ma	Location *	LS
Category	Earthen Levee			GPS Latitude/Longitude	
				Start	End
Item	Trim / Thin Trees			39.180447°	39.180447°
				-121.610036°	-121.610036°
DWR ID	DWR_RD0010_02_f_2017_56				
Comment Code					
T2 : Thin trees to allow visibility of the ground and room to flood fight.					
Inspector Comment					
Tree less than 4" in diameter needs to be removed, Fall 2018.

View looking downstream landside of a tree less than 4" in diameter that needs to be removed, Fall 2017.

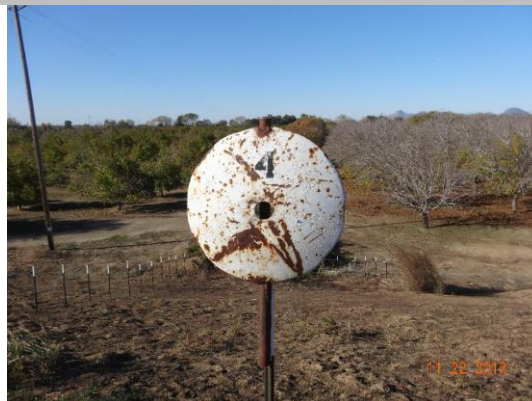
Photo 1 of 3 : UCIP_FA_2018_24821_44640.jpg

Comment Code						
Inspector Comment						
FS_ID:24821 DS_ID:21281 EP_NO: N/A Repair Type: Non-Urgent Crossing Status: Found UCIP Comments: 04/30/2013 Screw gate on landward side is blocked by sediment. Recommend removing sediment in front of gate. This crossing is referenced in the USACE Periodic Inspection as item USACE_CESPK_HON2_2013_p_0082. (DWR UCIP - O. Magana) FIELD_STRUCT_DESC: 24-inch corrugated metal gravity drainage pipe through the levee, 26 feet below the crown. Corrugated metal cutoff wall around the pipe at each shoulder. Flap gate on the waterside (WS) end. Slide gate on the landside (LS) end. Concrete headwall, saddle, and apron on the WS end. [Additional Reference(s): DWR Levee Log, 2005. USACE Sacramento O&M Manual 151, May 1953, (Station 149+88)]. FS Date: 4/30/2013

Marker visible on waterward side--No. 4.

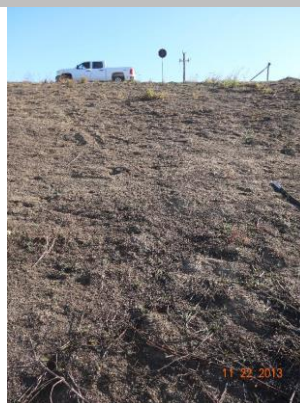
Photo 2 of 3 : UCIP_FA_2018_24821_44639.jpg

Comment Code						
Inspector Comment						
FS_ID:24821						
DS_ID:21281						
EP_NO: N/A						
Repair Type: Non-Urgent						
Crossing Status: Found						
UCIP Comments: 04/30/2013 Screw gate on landward side is blocked by sediment. Recommend removing sediment in front of gate. This crossing is referenced in the USACE Periodic Inspection as item USACE_CESPK_HON2_2013_p_0082. (DWR UCIP - O. Magana)						
FIELD_STRUCT_DESC: 24-inch corrugated metal gravity drainage pipe through the levee, 26 feet below the crown. Corrugated metal cutoff wall around the pipe at each shoulder. Flap gate on the waterside (WS) end. Slide gate on the landside (LS) end. Concrete headwall, saddle, and apron on the WS end. [Additional Reference(s): DWR Levee Log, 2005. USACE Sacramento O&M Manual 151, May 1953, (Station 149+88)].						
FS Date: 4/30/2013

View of waterward slope side.

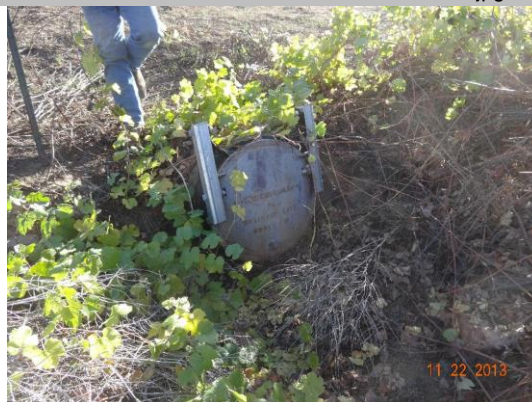
Photo 3 of 3 : UCIP_FA_2018_24821_44638.jpg

View of flap gate located on waterward side.

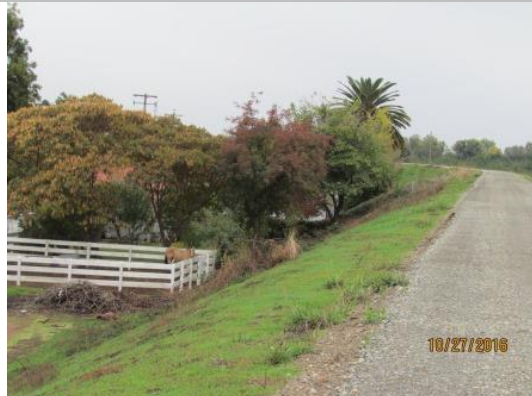
Photo 1 of 1 : FA_2018_RD0010_164_9_20180918_00002.jpg

LM Start	1.34	Rating **	M	Issue No.	9
LM End	1.34	Issue Type +	En	Location *	LS
Category	Earthen Levee			GPS Latitude/Longitude	
				Start	End
Item	Vegetation			39.182957 °	39.182957 °
				-121.609800 °	-121.609800 °
DWR ID	DWR_RD0010_02_s_2012_9				
Comment Code					
V6 : Landscaping					
Inspector Comment					
Landscaping and fence should be removed from levee toe and slope.

View of homeowners landscaping and fence that encroaches on the landside levee slope, looking downstream.

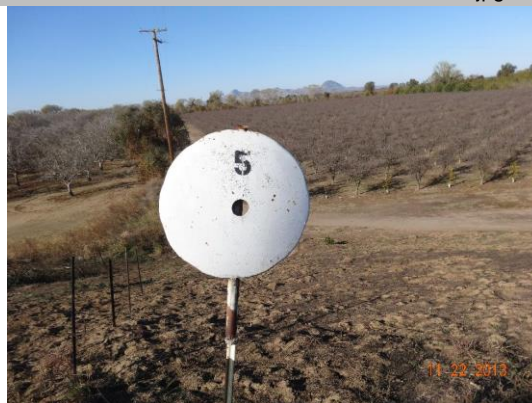
Photo 1 of 3 : UCIP_FA_2018_24822_44647.jpg

Comment Code						
Inspector Comment						
FS_ID:24822						
DS_ID:21282						
EP_NO: N/A						
Repair Type: No Action Needed						
Crossing Status: Found						
UCIP Comments: 04/29/2013 This crossing is referenced in the						
USACE Periodic Inspection as item						
USACE_CESPK_HON2_2013_p_0109. (DWR UCIP - O. Magana)						
FIELD_STRUCT_DESC: 36-inch corrugated metal gravity drainage pipe						
through the levee, 25 feet below the crown. Corrugated metal cutoff wall						
around the pipe at each shoulder. Flap gate on the waterside (WS) end.						
Slide gate on the landside (LS) end. Concrete headwall, saddle, and						
apron on the WS end. [Additional Reference(s): DWR Levee Log, 2005.						
USACE Sacramento O&M Manual 151, May 1953, (Station 164+65)].						
FS Date: 4/30/2013

Marker visible on waterward side--No. 5.

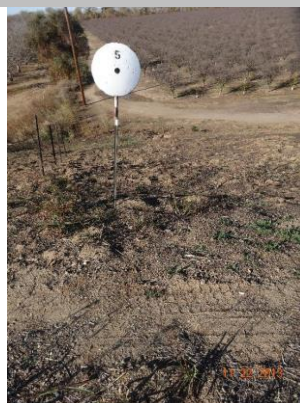
Photo 2 of 3 : UCIP_FA_2018_24822_44648.jpg

Overview of waterward slope--dense burrow activity on slope.

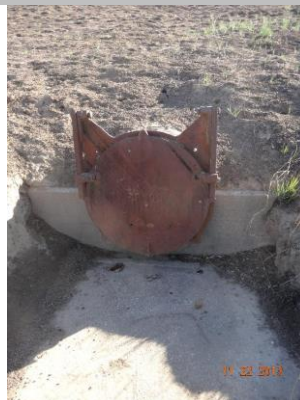
Photo 3 of 3 : UCIP_FA_2018_24822_44645.jpg

View of flap gate on waterward side.

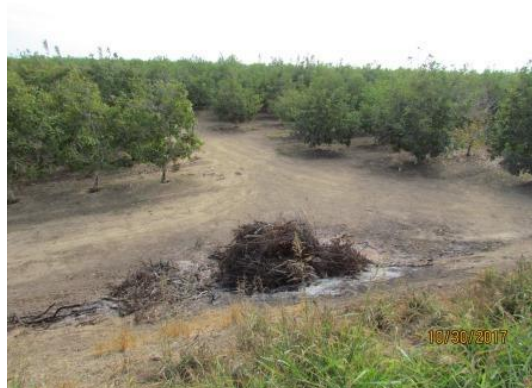
Photo 1 of 1 : FA_2018_RD0010_164_39_20180918_00014.jpg

LM Start	1.80	Rating **	M	Issue No.	39
LM End	1.80	Issue Type +	En	Location *	LS
Category	Earthen Levee			GPS Latitude/Longitude	
				Start	End
Item	Encroachments			39.189467 °	39.189467 °
				-121.607991 °	-121.607991 °
DWR ID	DWR_RD0010_02_s_2016_39				
Comment Code					
PR : Prunings					
Inspector Comment					
Remove prunings from toe of slope, Fall 2018.

View of prunings at landside levee toe, Fall 2017.

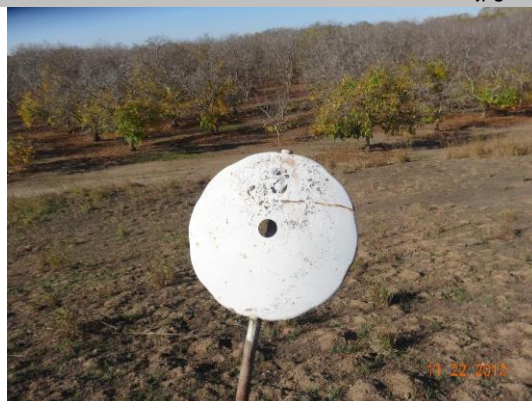
Photo 1 of 3 : UCIP_FA_2018_27773_51461.jpg

LM Start	3.10	Rating **	M	Issue No.	75	
LM End	3.10	Issue Type +	En	Location *		
Category	Supplemental			GPS Latitude/Longitude		
				Start	End	
Item	DWR UCIP Field Study			39.208193°	39.208193°	
				-121.609909°	-121.609909°	
DWR ID	21283					
Comment Code						
Inspector Comment						
FS_ID:27773 DS_ID:21283 EP_NO: N/A Repair Type: Non-Urgent Crossing Status: Found UCIP Comments: 04/30/2013 High rodent activity along pipe alignment--animal control would be beneficial. This crossing is referenced in the USACE Periodic Inspection as item USACE_CESPK_HON2_2013_p_0150. (DWR UCIP - O. Magana) FIELD_STRUCT_DESC: 30-inch corrugated metal gravity drainage pipe through the levee, 22.5 feet below the crown. Flap gate on the waterside (WS) end. Metal marker on the WS shoulder. [Additional Reference(s): DWR Levee Log, 2005]. FS Date: 4/30/2013

Marker visible on waterward side.
